# **Appendix B**

## **Summary of Public Involvement**

**SECTION 18 DEMOLITION DISPOSITION  
PHYSICAL CONDITION ASSESSMENT (PCA)**

**TIDEWATER GARDENS -  
NORFOLK REDEVELOPMENT HOUSING AUTHORITY  
450 WALKER STREET, NORFOLK, VIRGINIA 23504**

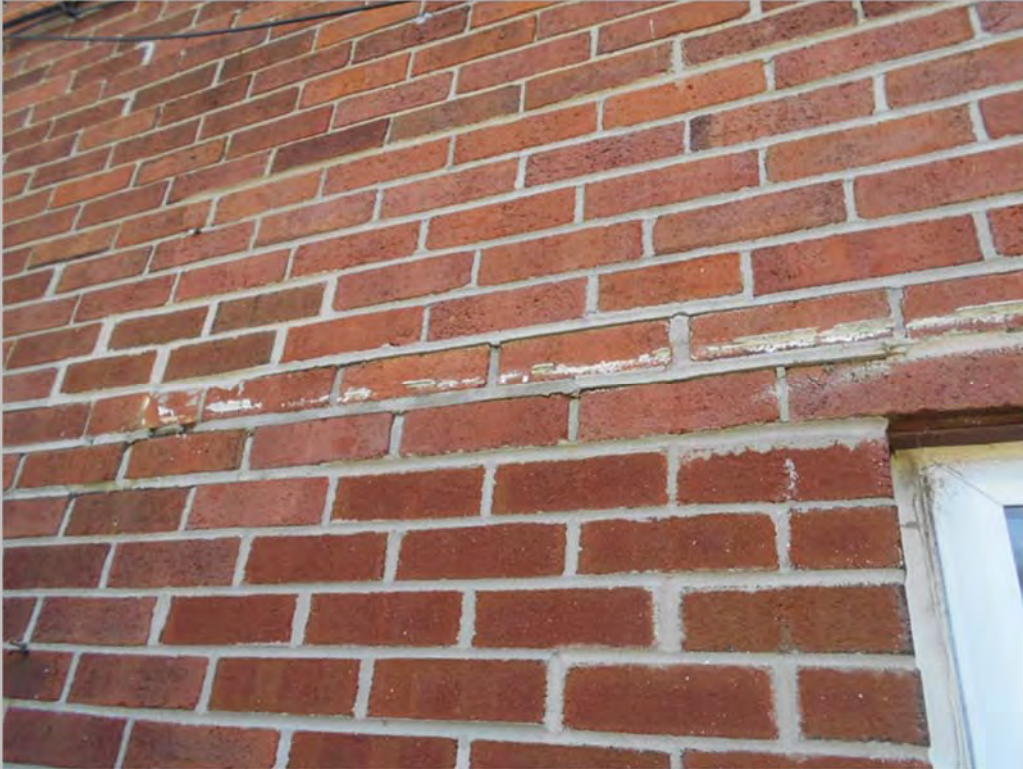
**PHOTO #7**

Typical deteriorated brick masonry

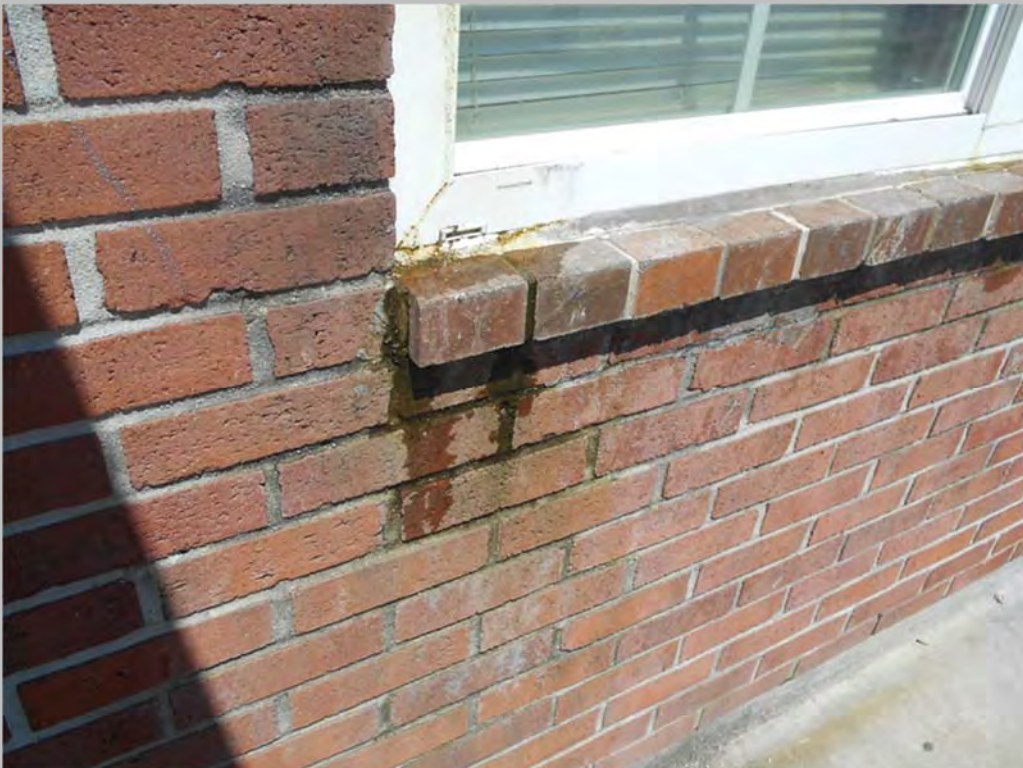
**PHOTO #8**

Typical deteriorated and stained brick masonry

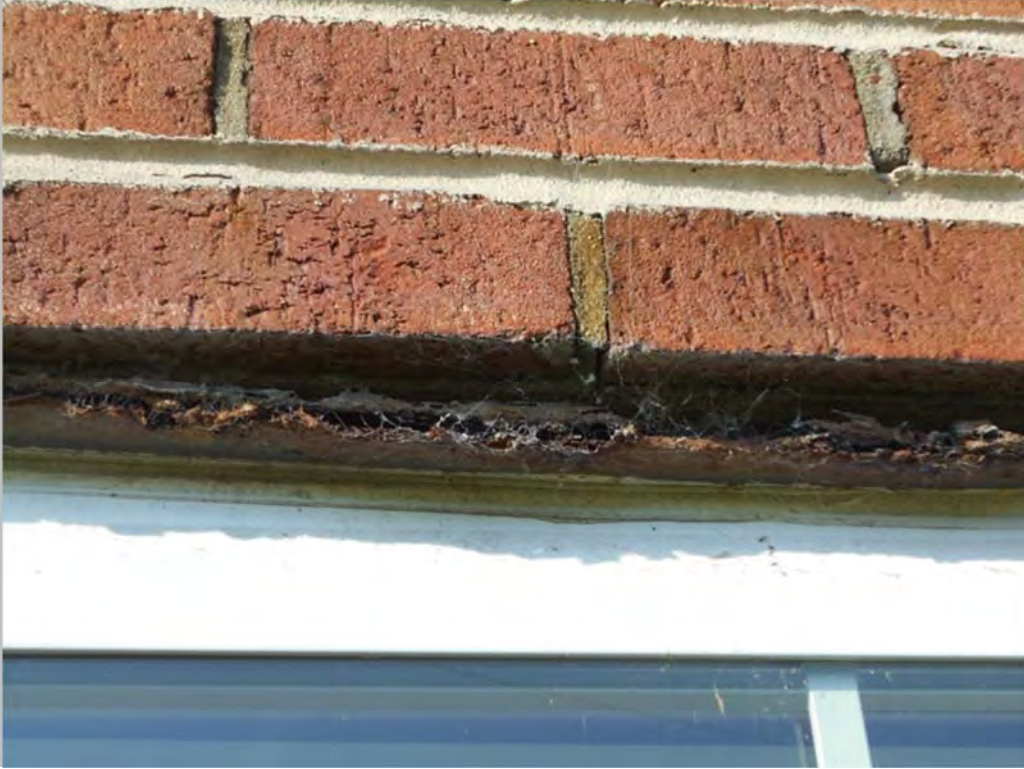
**PHOTO #9**

Typical deteriorated steel lintels

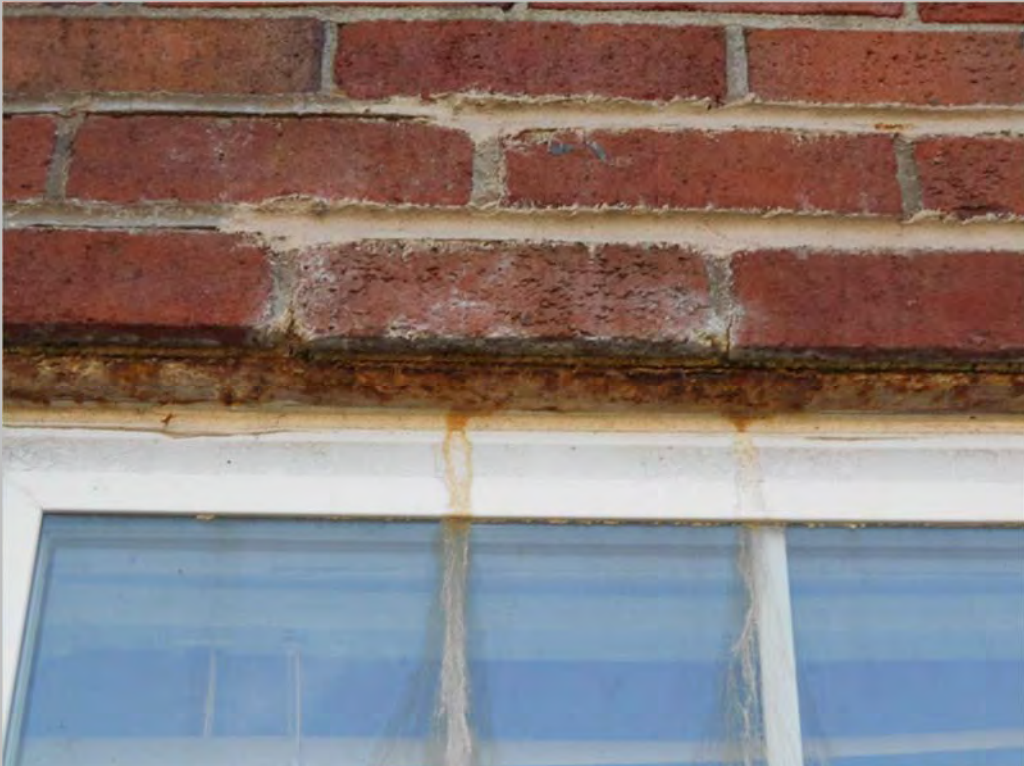
**PHOTO #10**

Typical deteriorated steel lintels

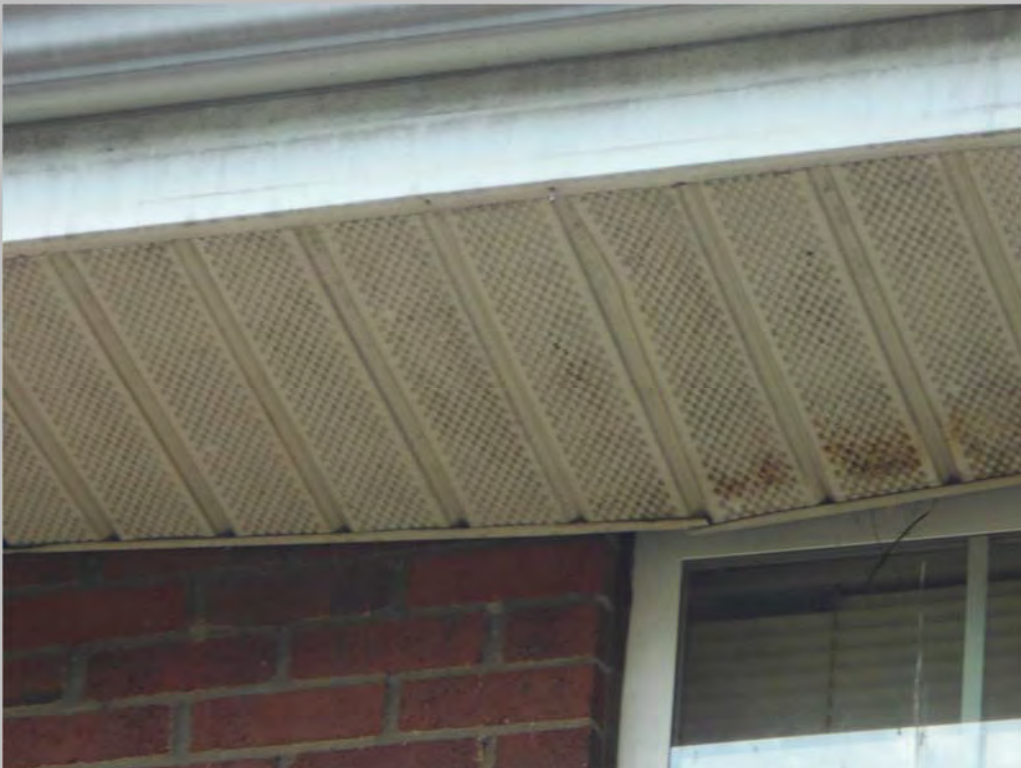
**PHOTO #12**

Typical deteriorated soffits

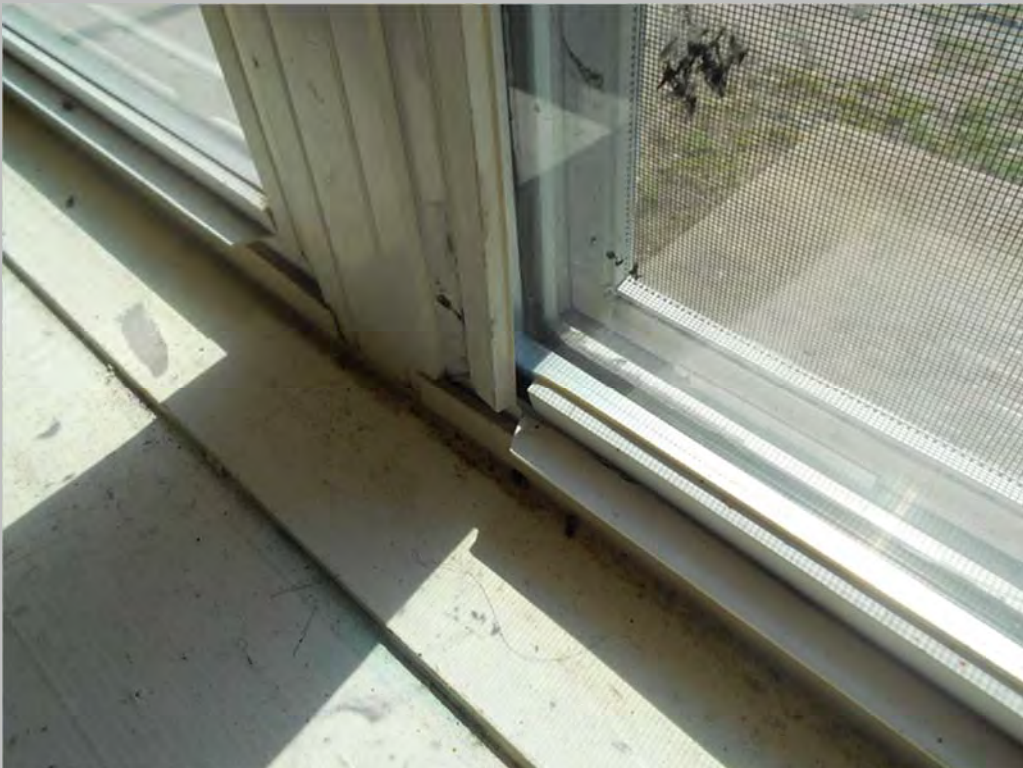
**PHOTO #34**

Typical dwelling unit windows – damaged and poorly installed

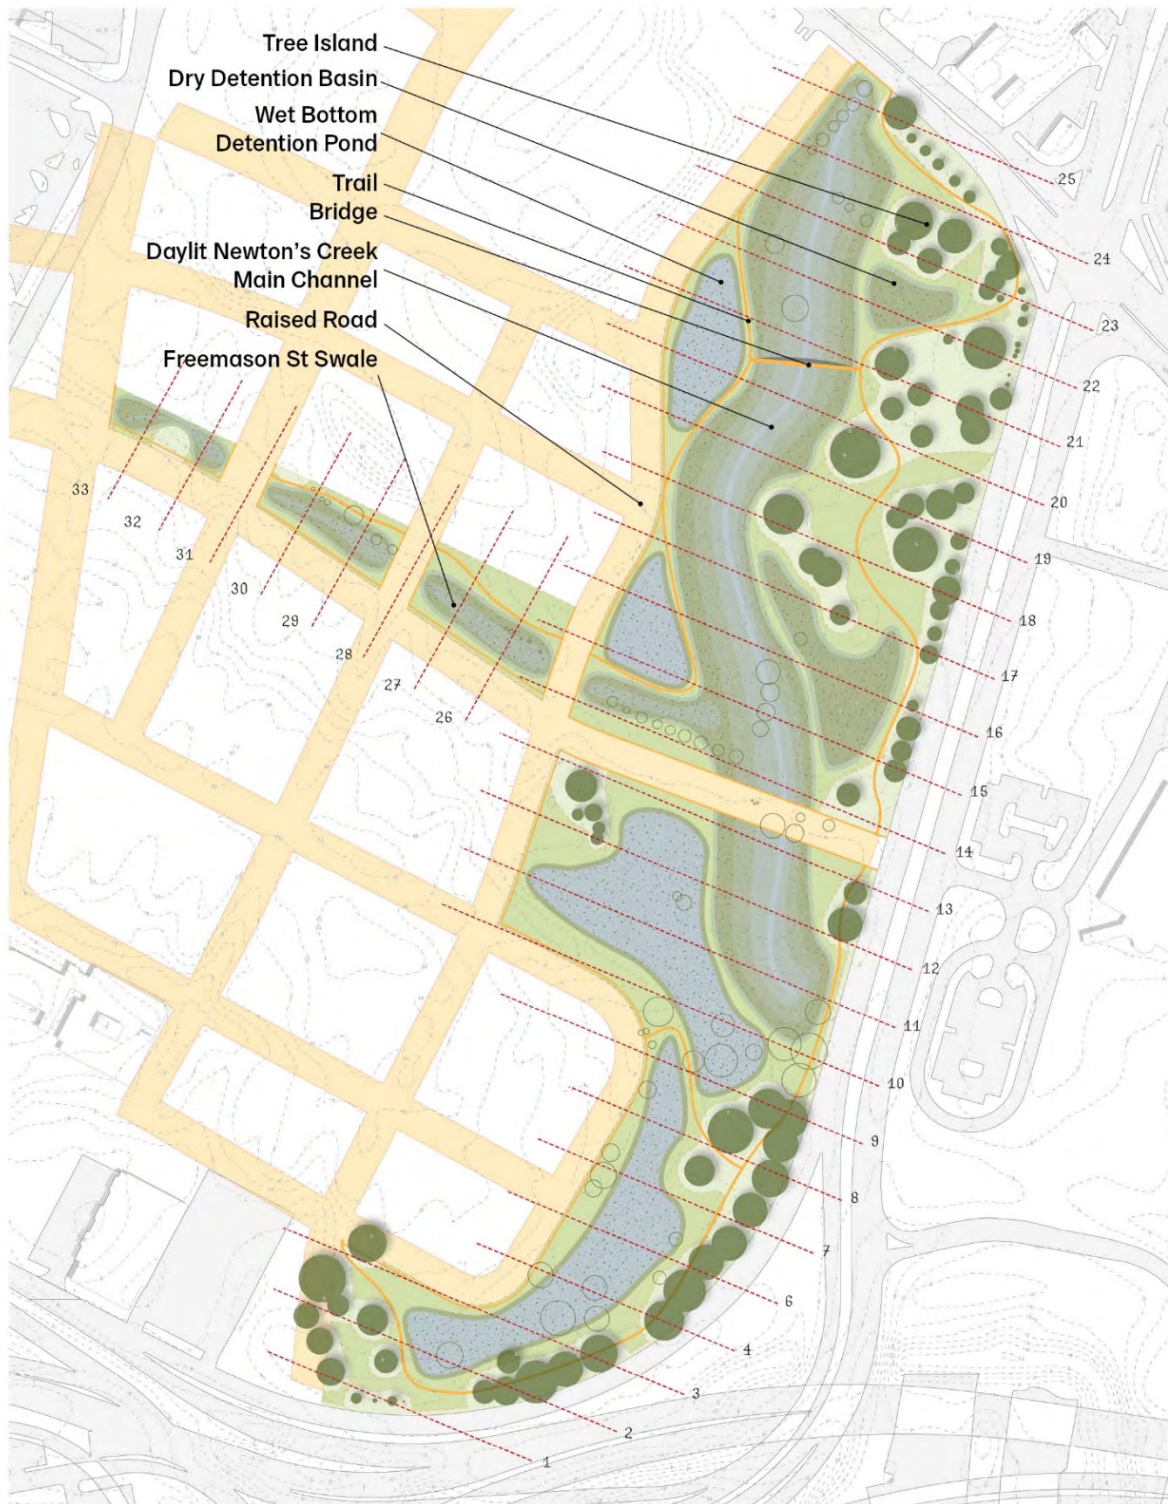
Figure ES-1: St. Paul's Blue/Greenway early concept

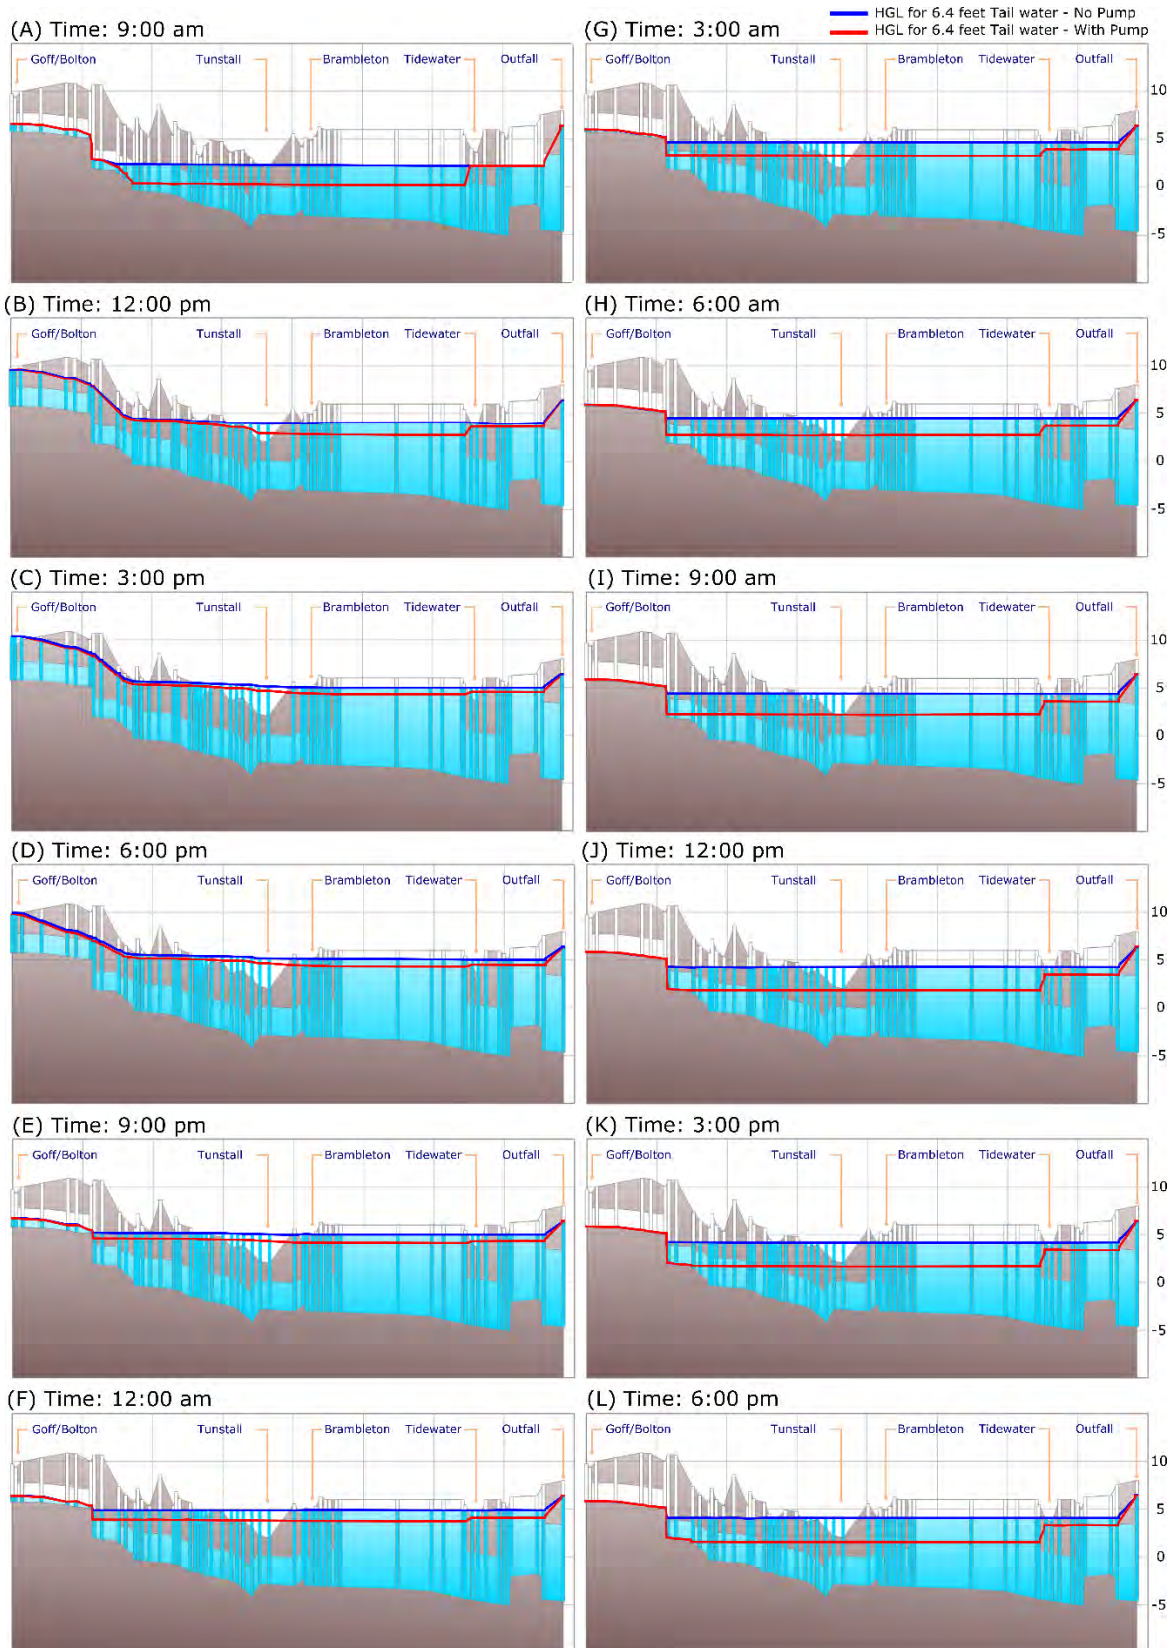
Figure 2-11: Comparison of peak water elevation time series with and without pumps, 25-yr storm w/ 3 ft sea level rise

Overall, the model indicates concept blue/greenway will function passively in the near-term but will require pumping features to provide a consistent level of protection as sea level rises.
