20 South 2nd Avenue

23 South 3rd Avenue

Mount Vernon, Westchester County, New York

Phase II Site Investigation Report

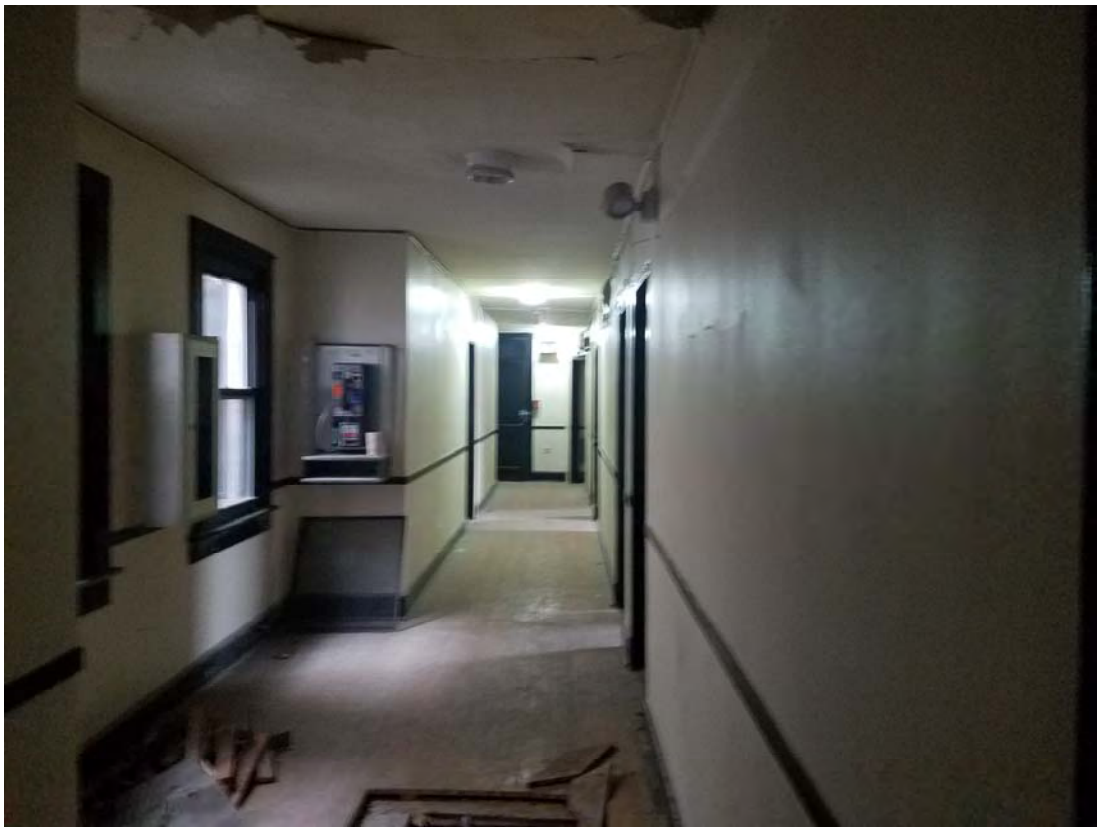
Photograph No. 9: Representative photograph of interior areas within the eastern potions of the subject building second floor.

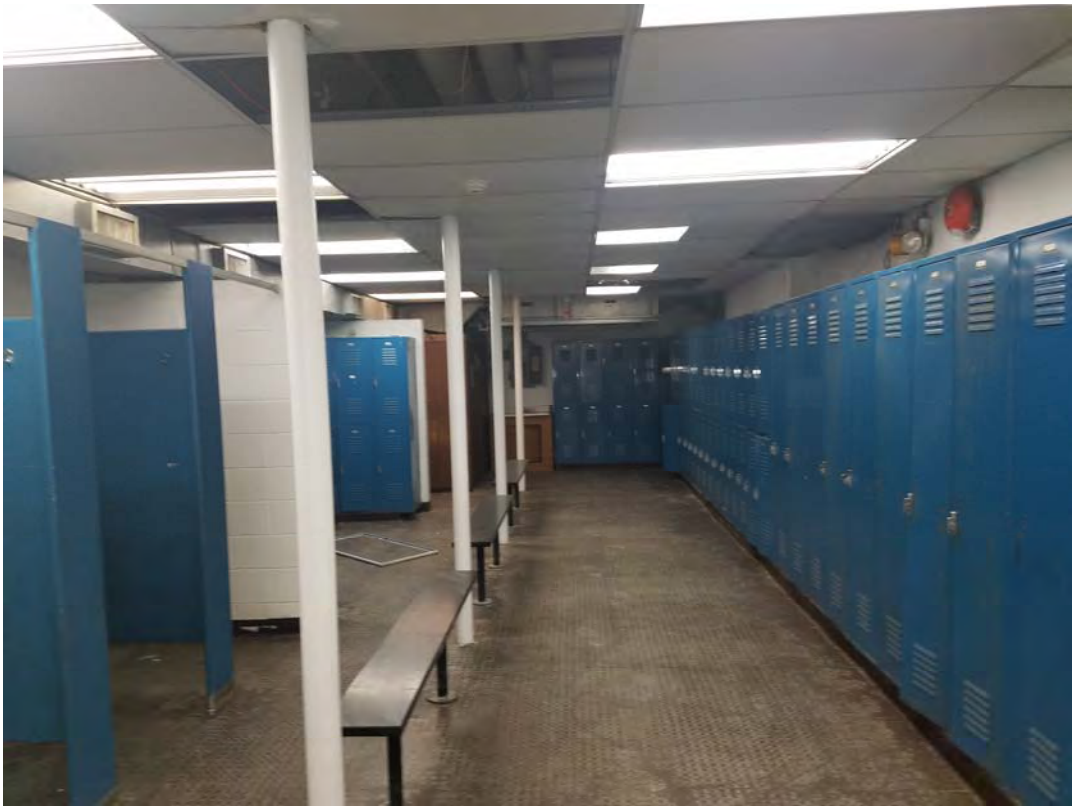
Photograph No. 12: Representative photograph of the locker rooms within the western portions of the subject building first floor.

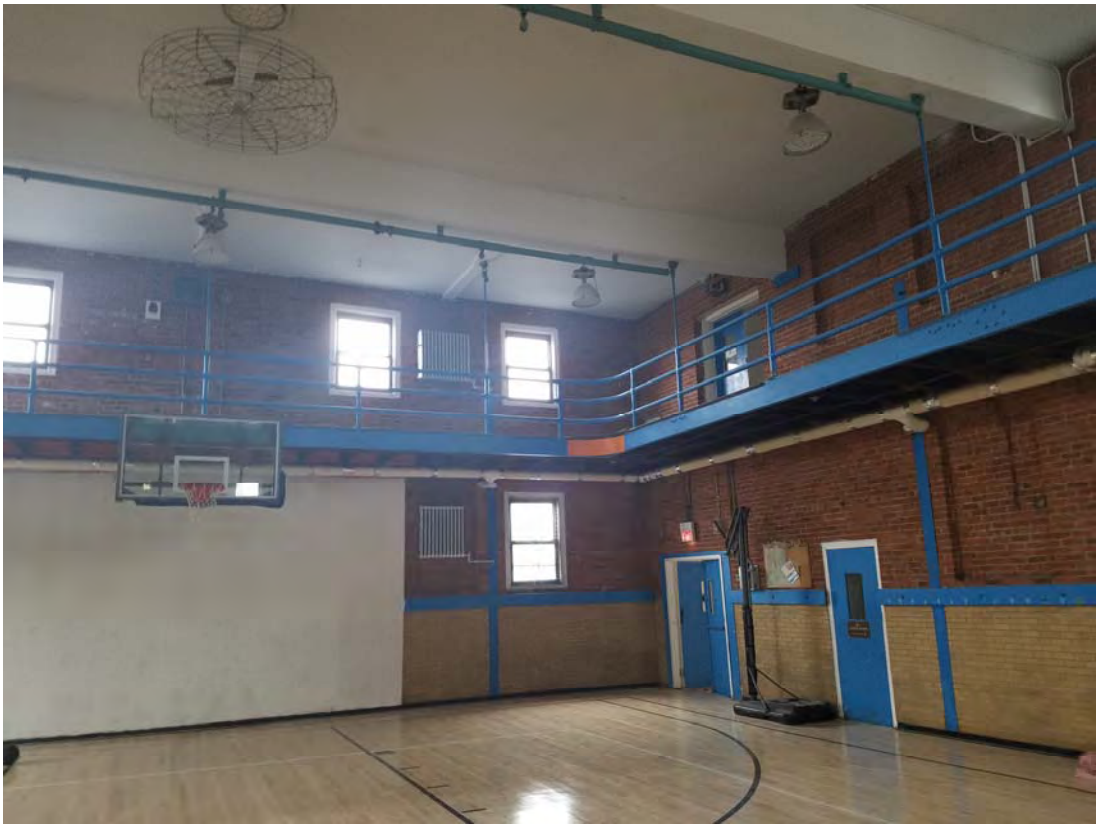
Photograph No. 13: Photograph of the gymnasium and atrium track within the western portions of the subject building second floor.

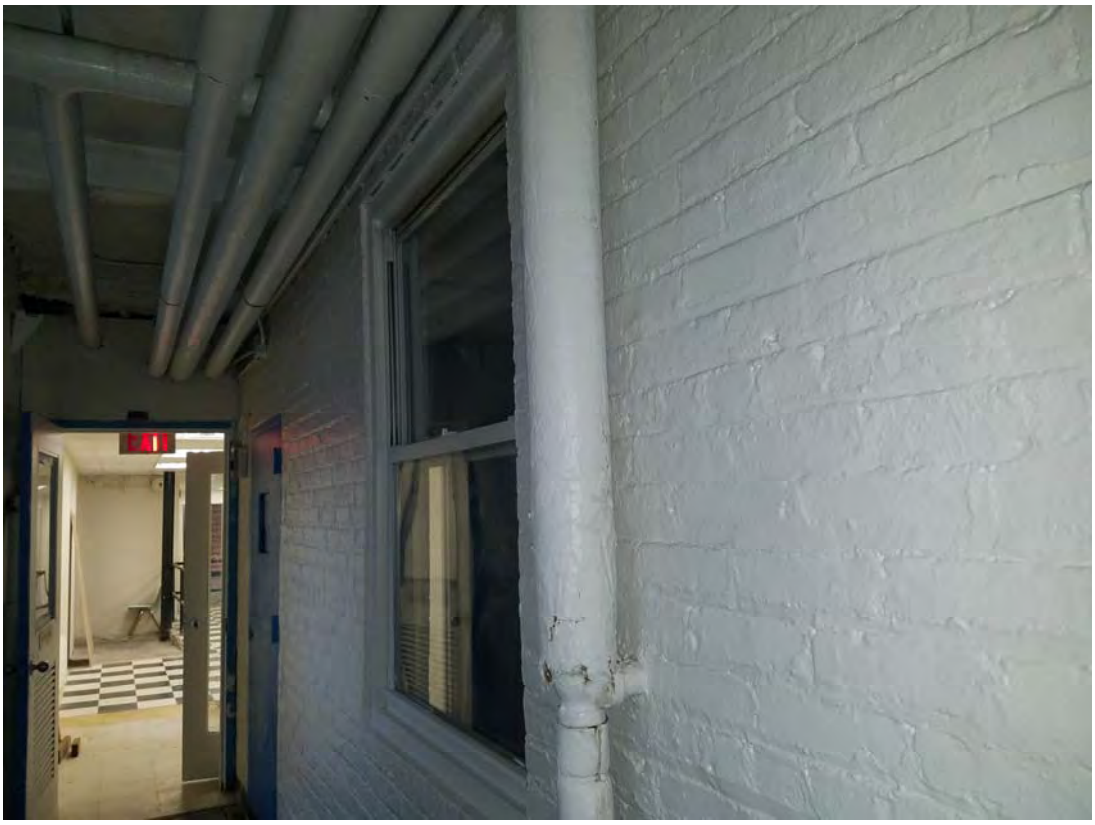
- Given the age of the subject building, there is a potential for asbestos containing material (ACM) to be present. Suspect ACM observed during the visual inspection included pipe insulation and floor tiles.

Photograph No. 23: Representative photograph of the suspect ACM pipe insulation located throughout the subject building.
